ZQ-6057-V-4

Figure 9-6 TEST NO. 3 – PRE TEST COLLISION CONFIGURATION

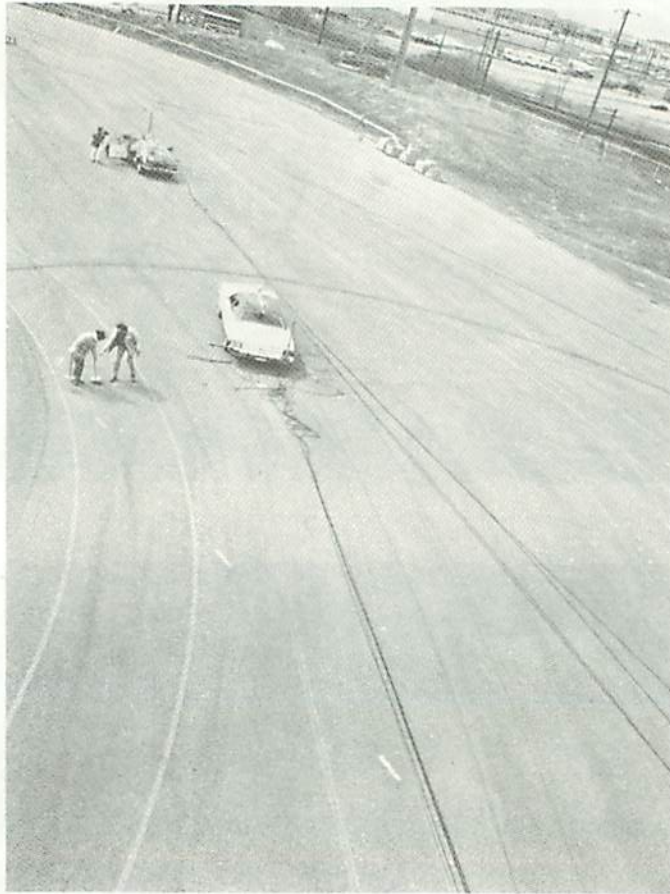
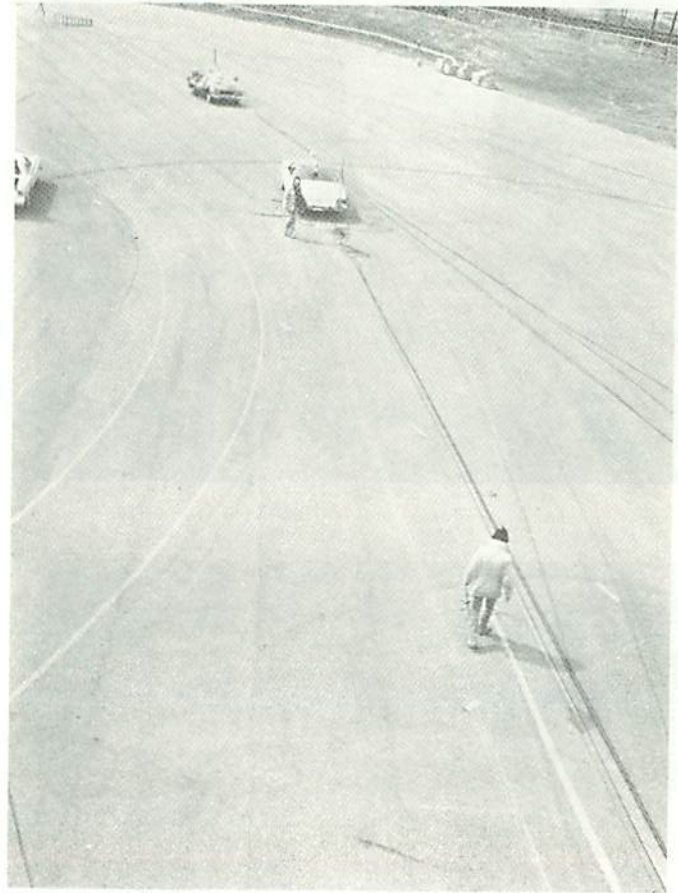
Figure 9-7 TEST NO. 3 – POST TEST COLLISION SCENE

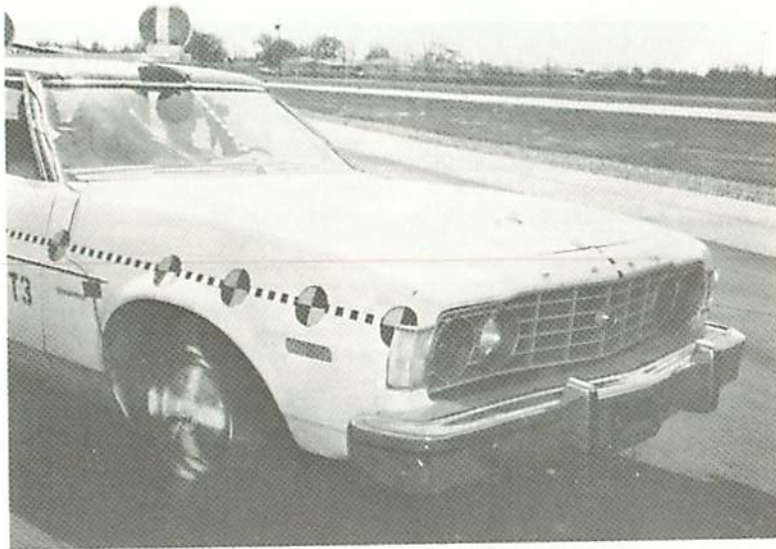
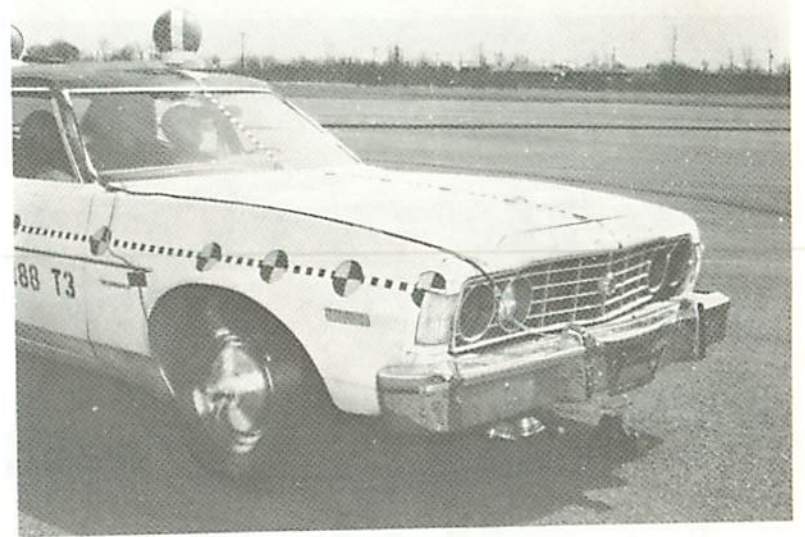
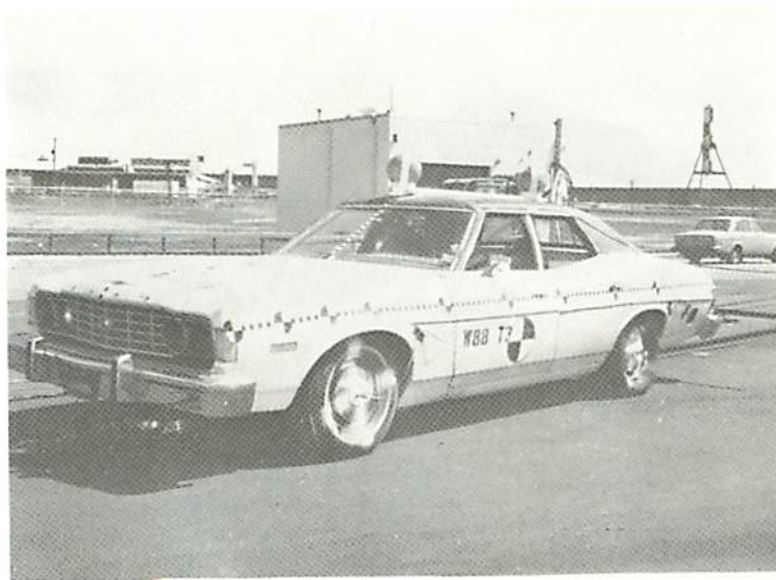
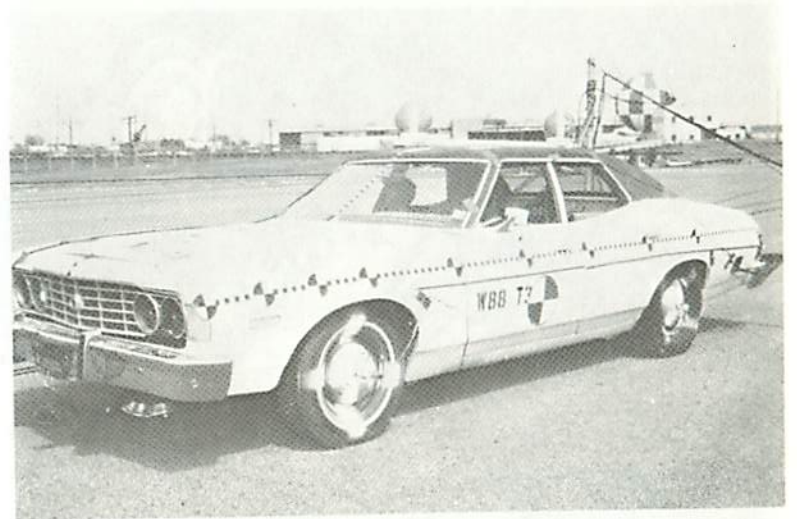
Figure 9-8 TEST NO. 3 – PRE AND POST EXTERIOR VIEWS, CAR NO. 1 - TORINO

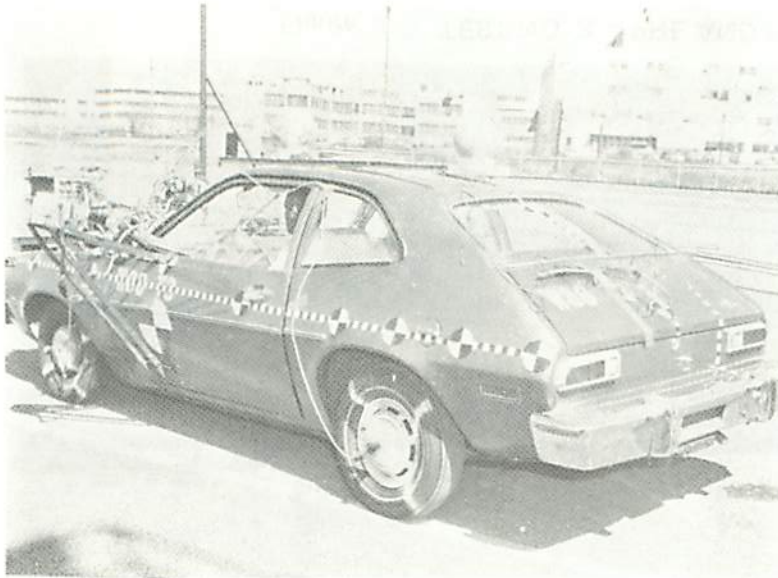
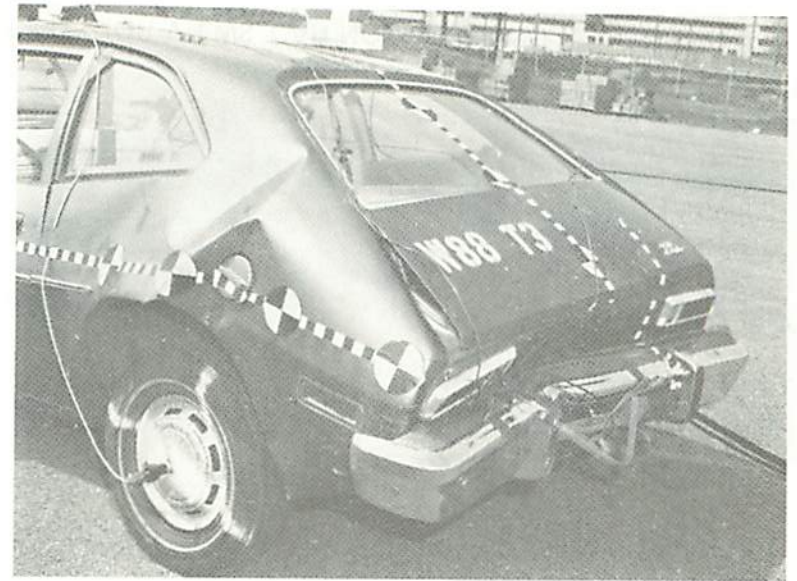
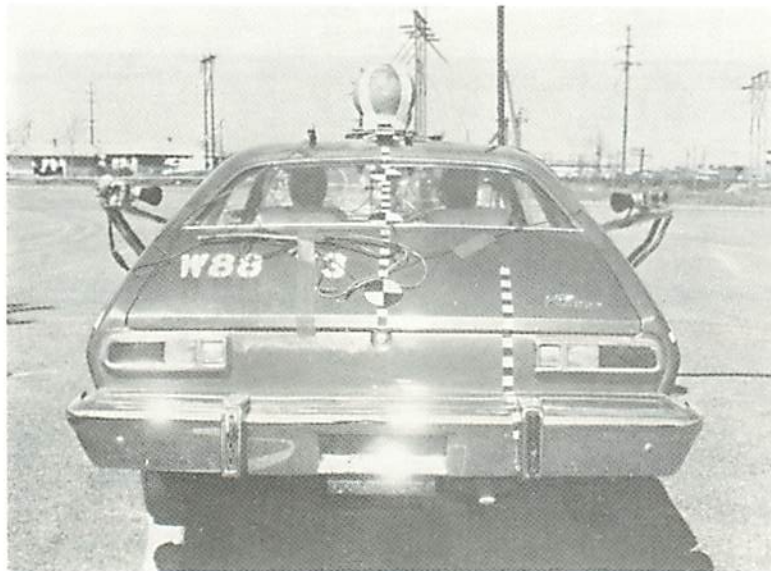
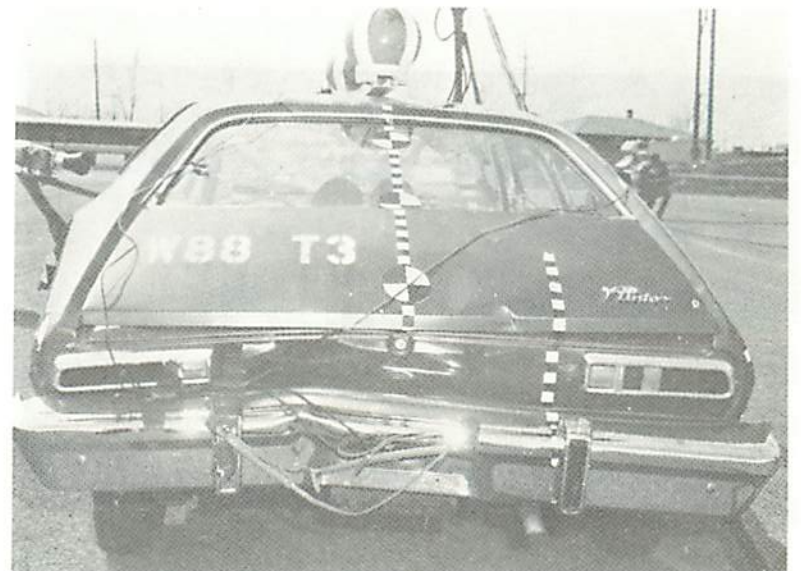
Figure 9-9 TEST NO. 3 – PRE AND POST EXTERIOR VIEWS, CAR NO. 2 - PINTO

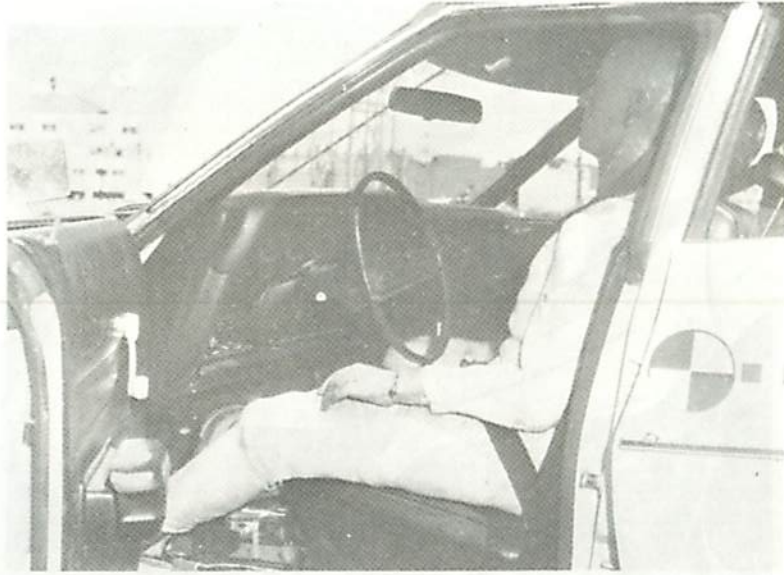
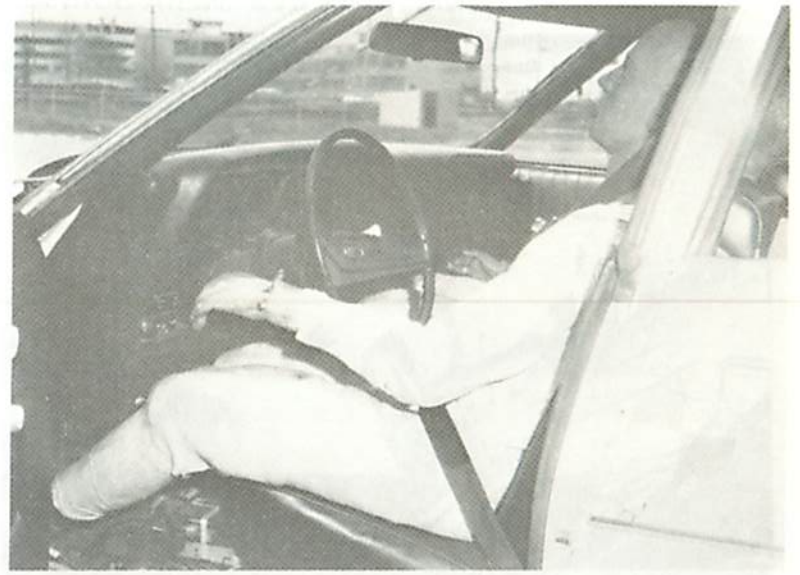
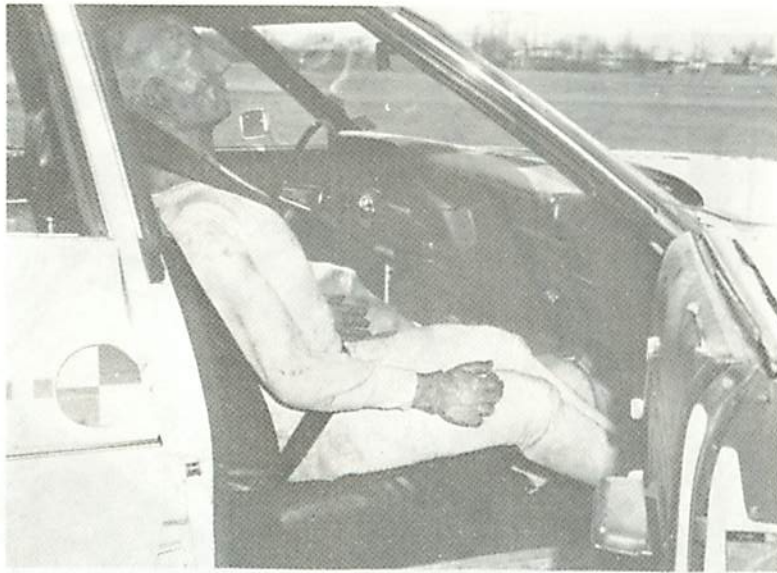
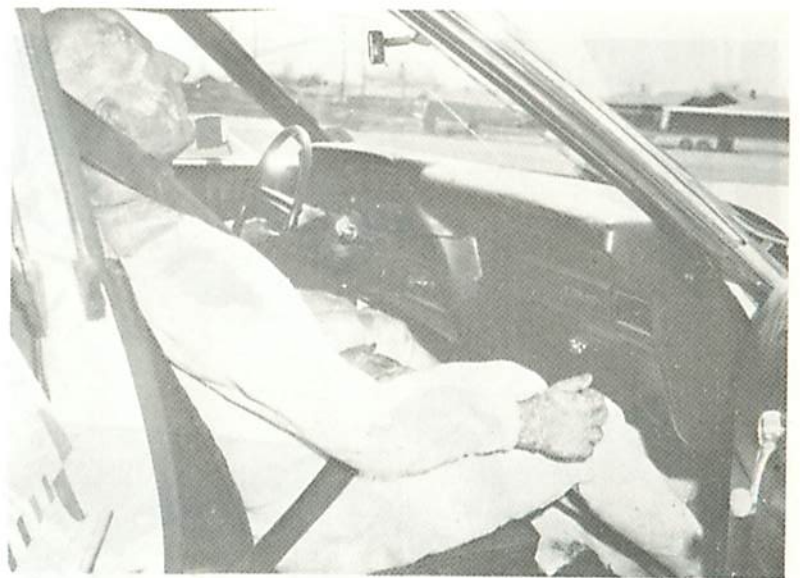
Figure 9-10 TEST NO. 3 – PRE AND POST INTERIOR VIEWS, CAR NO. 1 - TORINO

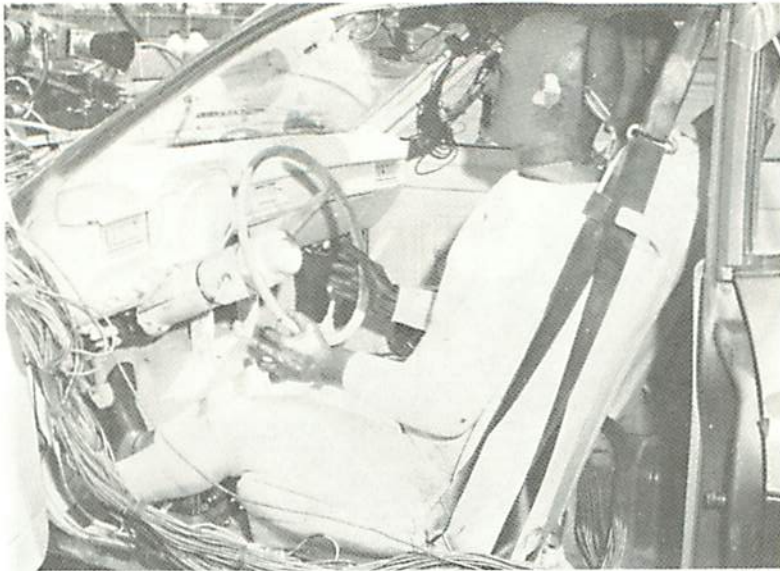
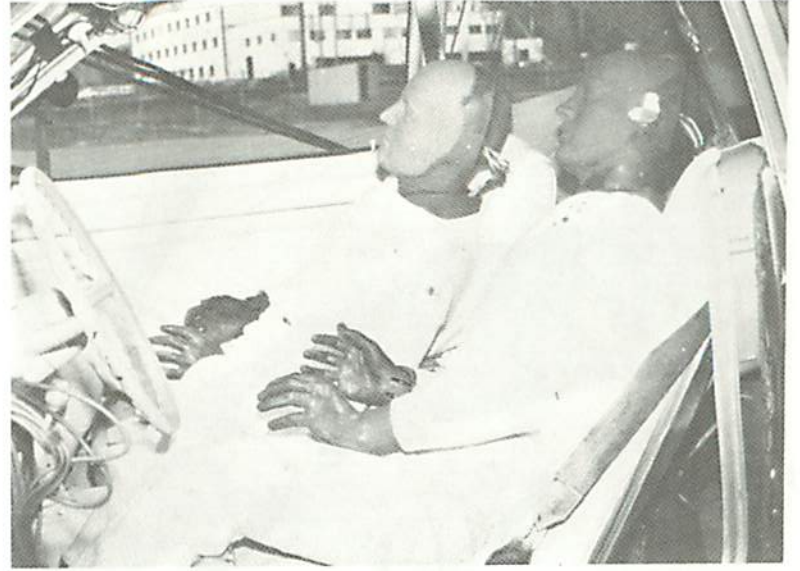
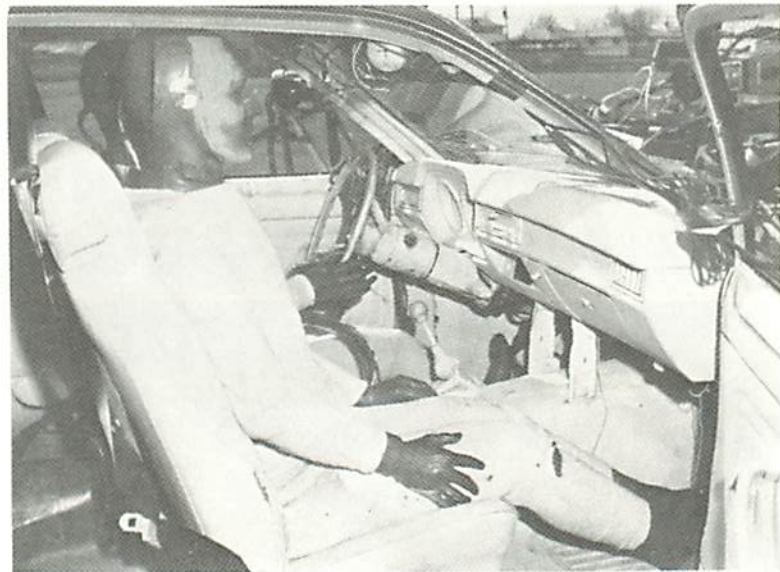
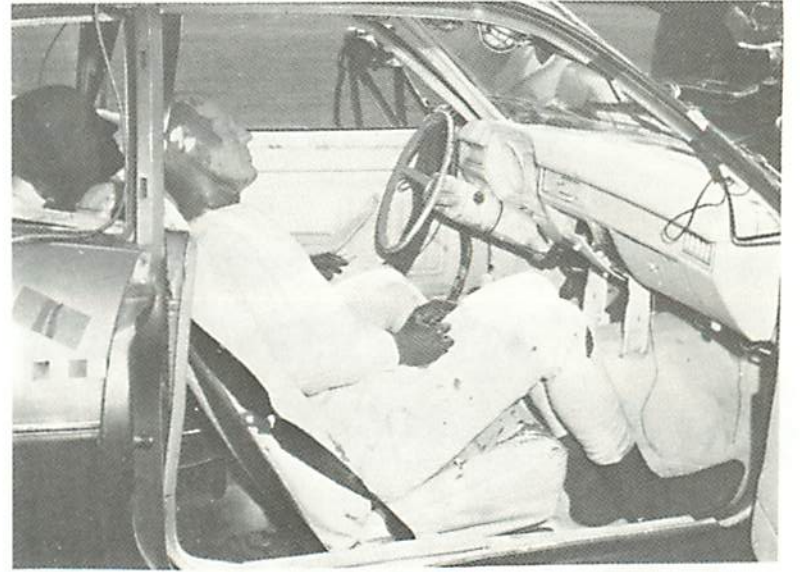
Figure 9-11 TEST NO. 3 – PRE AND POST INTERIOR VIEWS, CAR NO. 2 - PINTO
