PUBLISHED PROJECT REPORT PPR073

FRICTION TESTS ON CONTAMINATED ROAD SURFACES

by R F Lambourn and H E Viner (TRL Limited)

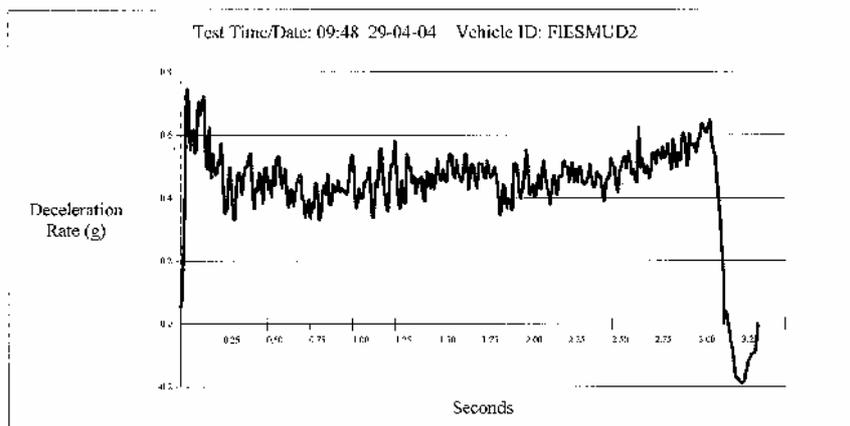
Figure 4.12 SkidMan graph for Fiesta sliding to a halt from 60 km/h on asphalt covered with wet clay

Figure 4.11 shows the values measured on asphalt when covered with wet clay. The results are rather erratic, due, no doubt, to the irregular nature of the contaminant. Figure 4.12, for example, shows how the deceleration varied during the braking of the Fiesta from 80 km/h. Again, it can be seen that the friction, with sliding values of around 0.5, and lower than the wet friction on this surface, is not markedly low. Figure 4.13 shows the variation in friction observed during a PFT test on the wet clay. The spikes in friction observed at around 0.5s coincide with variations in the test wheel load, presumably as a result of lumps in the clay, but the variation in friction coefficient between 1s and 2.5s must indicate a variation in the friction characteristics of the clay since the test wheel load remains constant.

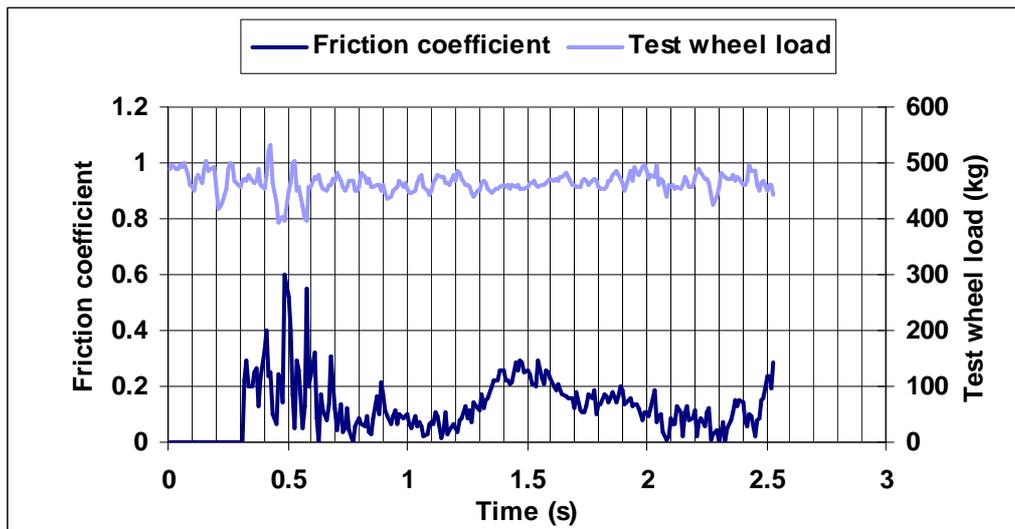
Figure 4.13 PFT graph for 60km/h test on asphalt contaminated with clay

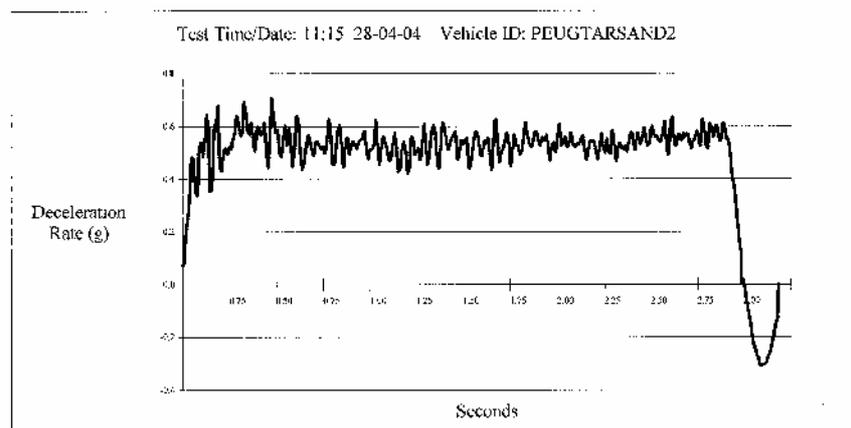
With the skid cars there was no apparent dependence of deceleration on speed, and Figure 4.16 shows the SkidMan graph for the Peugeot braking from 60 km/h. Figure 4.17 shows that, as for the PFT test on clay, there is a variation in test wheel load that appears to coincide with variation in friction coefficient. Since the sand was not lumpy when spread, a possible explanation could be that it builds up in front of the locked, smooth tyre until it is compacted to an extent that the tyre is able to ride over it, causing the variation in wheel load.

Figure 4.16 SkidMan graph for Peugeot sliding to a halt from 60 km/h on asphalt covered with coarse sand
