# High Speed Rear Impact Crash Test

## Basic Test Notebook

*A Supplement to the High Speed Rear Impact Crash Test Video*

Failure Analysis Associates, Inc.

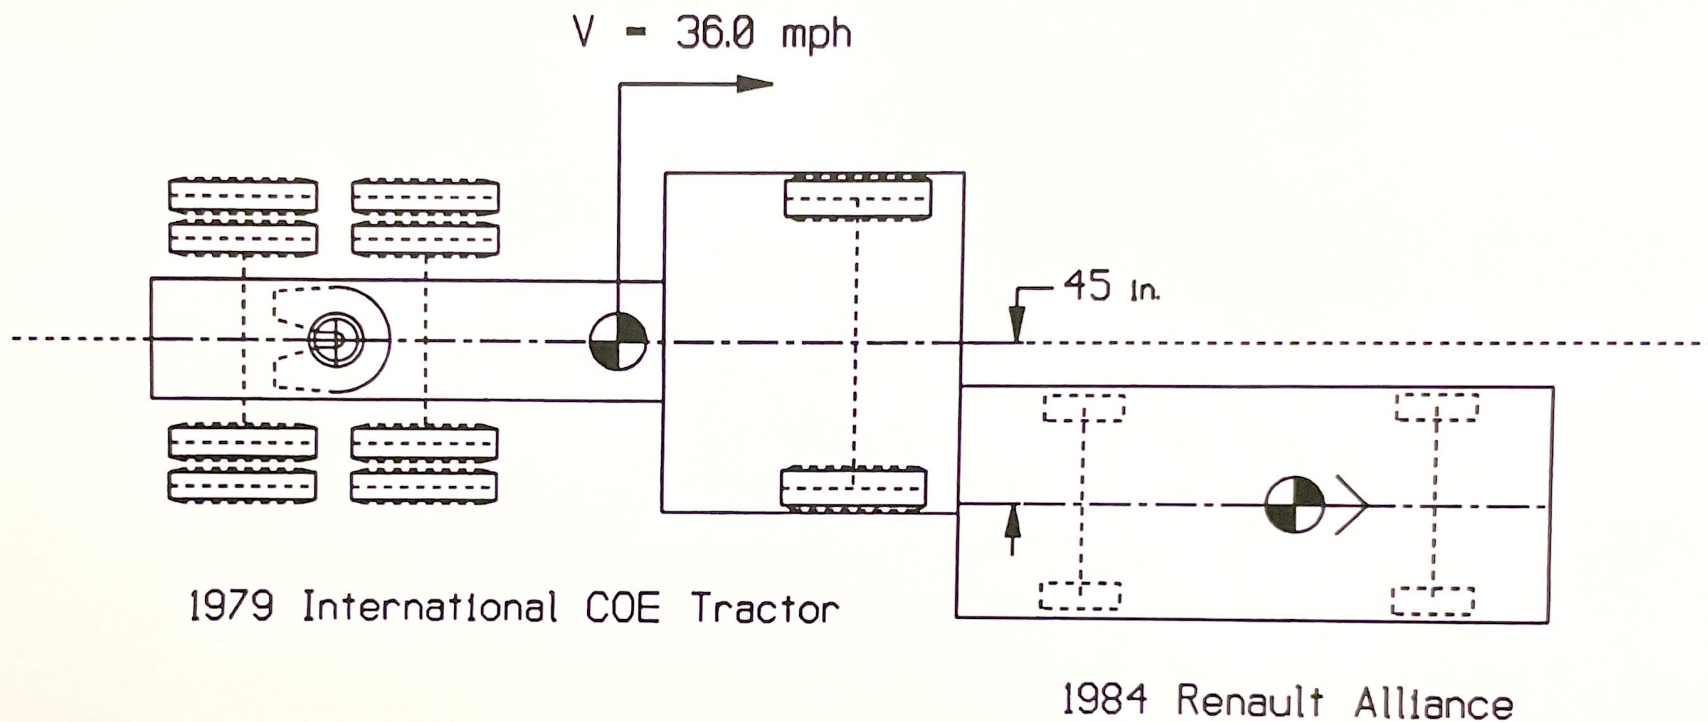
SAE TOPTEC  
00G40PH-SAE1

IMPACT CONFIGURATION

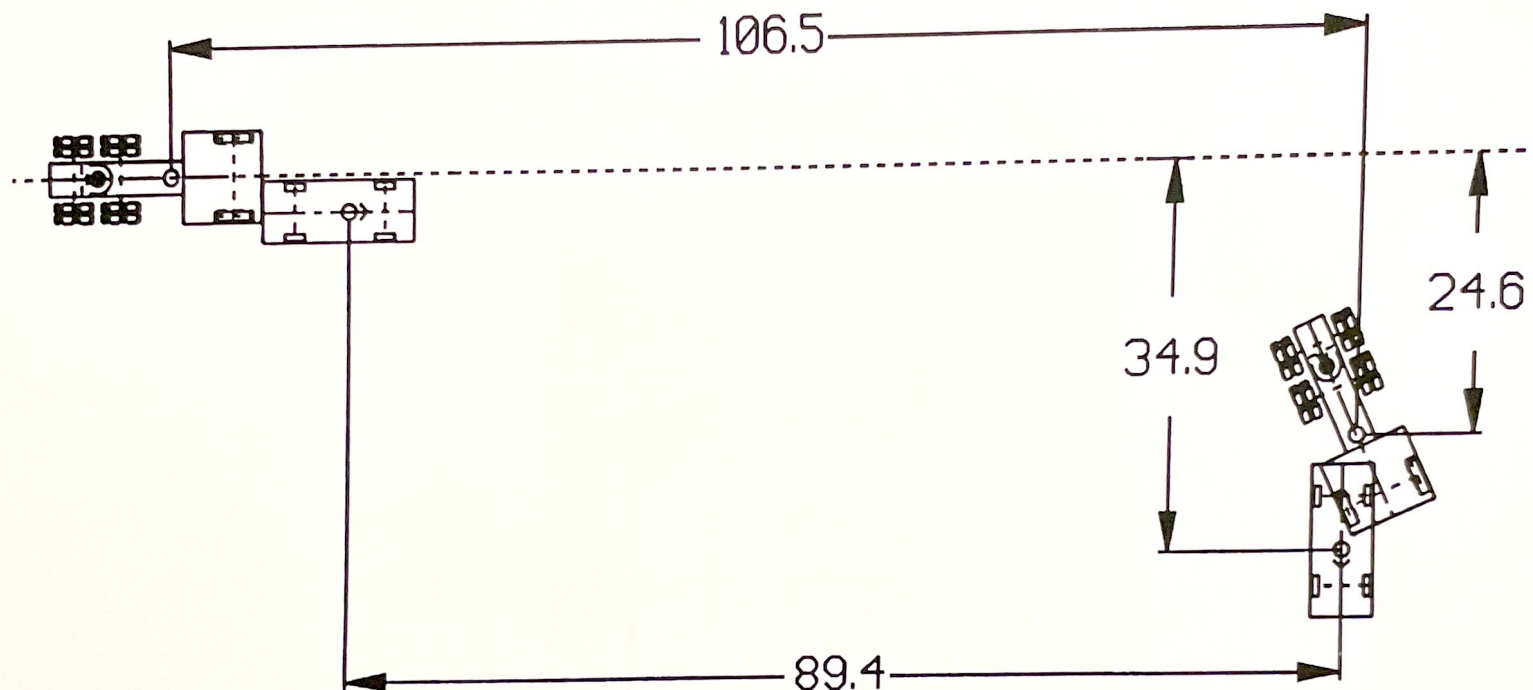
SAE TOPTEC  
00G40PH-SAE1

ALL DIMENSIONS IN FEET

IMPACT AND REST POSITIONS
